Root Canal Treatment and Esthetic Rehabilitation of Maxillary Central Incisor with Inclination Correction : A Case Report

Objective: to describe the root canal treatment and PFM crown restoration of tooth 21 with inclination correction to restore proper tooth function and achieve optimal aesthetics

Case: A 48-year-old female patient visited RSGMP UNIMUS, complaining of a cavity in her upper left front tooth. The diagnosis for tooth 21 was Acute Apical Endodontitis (AAE) with pulp necrosis and normal apical tissue. The planned treatment included root canal treatment followed by PFM crown restoration with fiber-reinforced composite (FRC) post support.

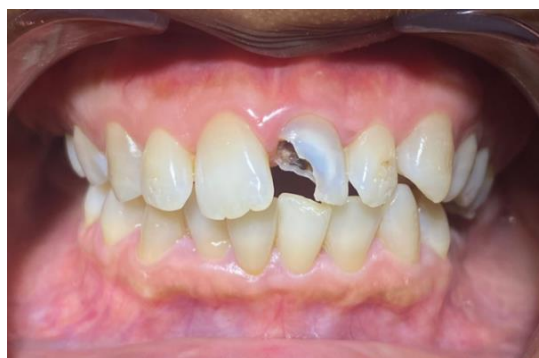
Figure 1. Intraoral photo of tooth 21.

The patient's general health was good. Probing (-): No tactile response, Percussion (-): No abnormalities in the periodontal or periapical tissues, Palpation (-): No soft tissue fluctuation, Cold vitality test (CE) (-): No response to cold stimuli, Mobility (0°): No looseness detected. Extraoral examination showed no abnormalities. Intraoral examination revealed caries extending from the mesio-incisal area into the pulp chamber of tooth 21 (Figure 1). Clinical examination showed:

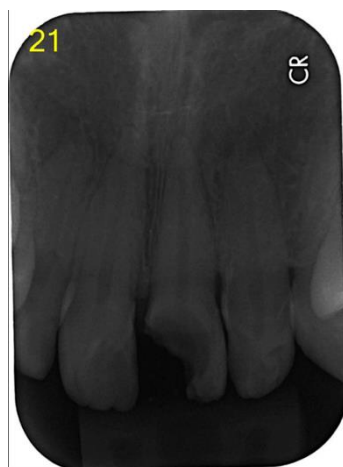
Figure 2. Periapical radiograph of tooth 21.

A periapical radiographic examination showed a radiolucent area on the mesio-incisal part extending into the pulp chamber. The image displayed one root, a single straight root canal, a normal periodontal ligament, a normal lamina dura, and normal alveolar bone and periapical structures (Figure 2). Based on the patient's history, clinical examination, and supporting tests, the diagnosis according to the American Association of Endodontists (AAE) for tooth 21 was Pulp Necrosis with normal apical tissue.
